DOT/FAA/CT-94/119

# Evaluation of Alternative Pavement Marking Materials

January 1995

Final Report

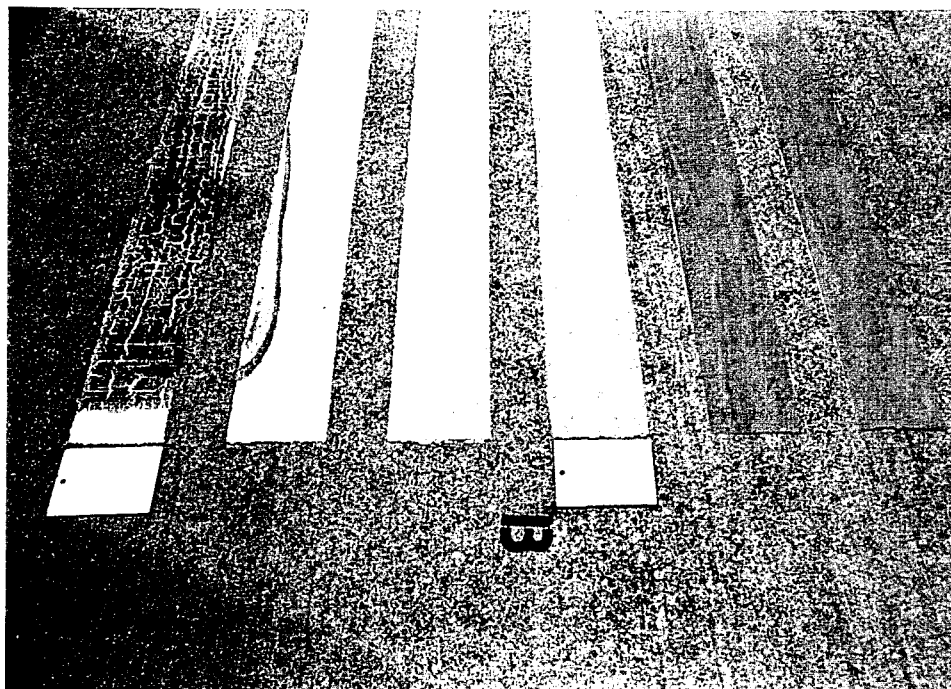
The taxiways Bravo and Hotel test stripes were each inspected on a monthly basis. One stripe of epoxy material (Epoxy no. 2, white, non-beaded) was noted to have not completely cured and assumed a blackened appearance. The blackened appearance was a result of the partially cured epoxy collecting the dirt from the main gear of the aircraft and vehicle tires as they passed over the test stripe. One benefit to be mentioned is that the material remained in place even though only partially cured. The test stripe did not delaminate from the concrete surface therefore eliminating the potential for foreign object damage (FOD).

FIGURE A-21. EPOXY NO. 2 - INCOMPLETE HARDENING

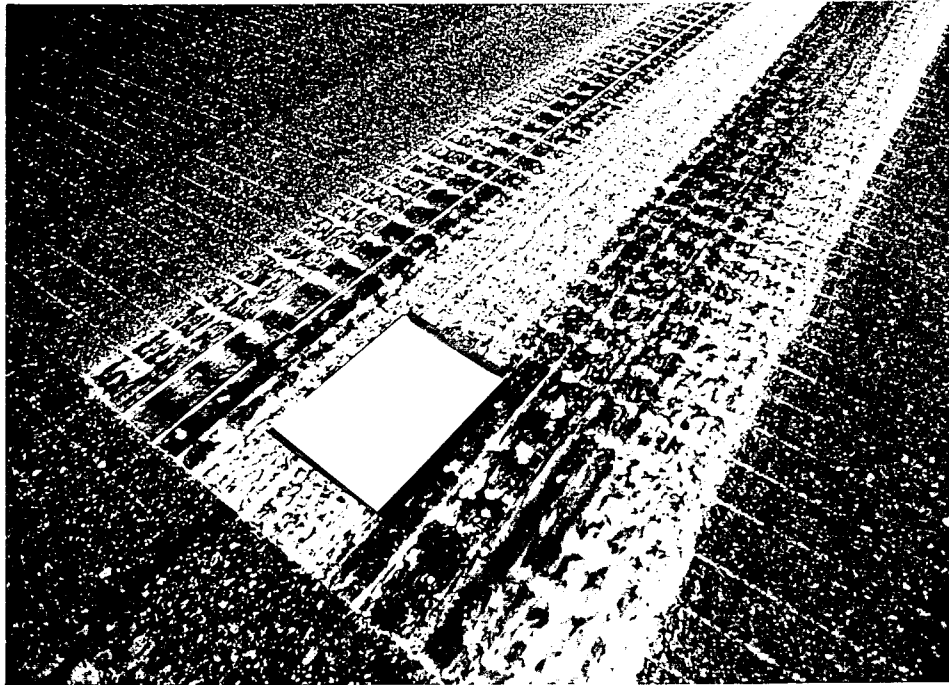
FIGURE A-22. RUBBER ACCUMULATION ON RUNWAY TEST STRIPE

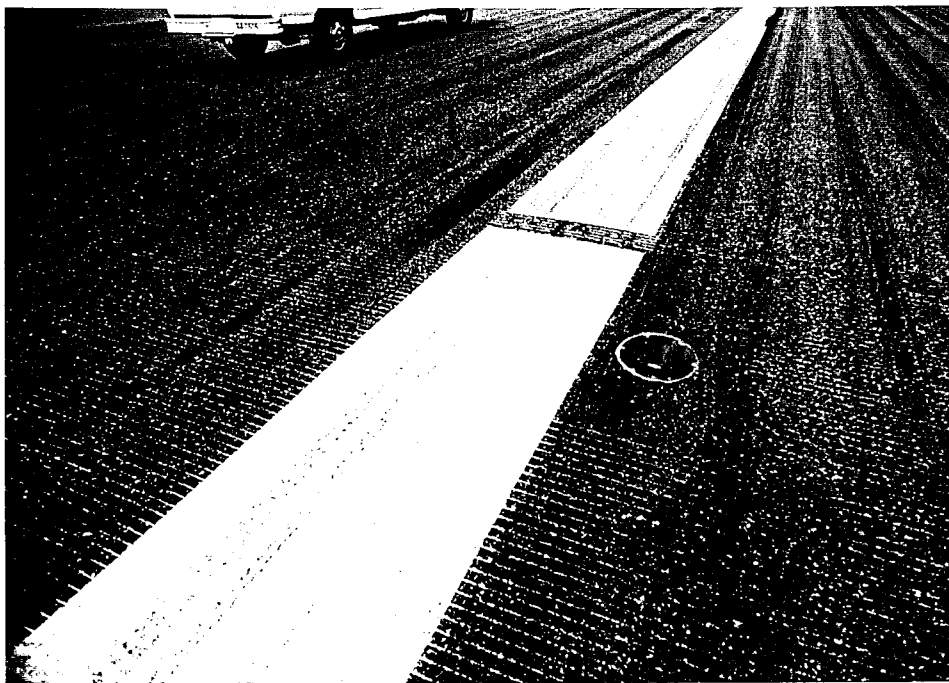
FIGURE A-23. COLOR VARIANCE - ATLANTIC CITY

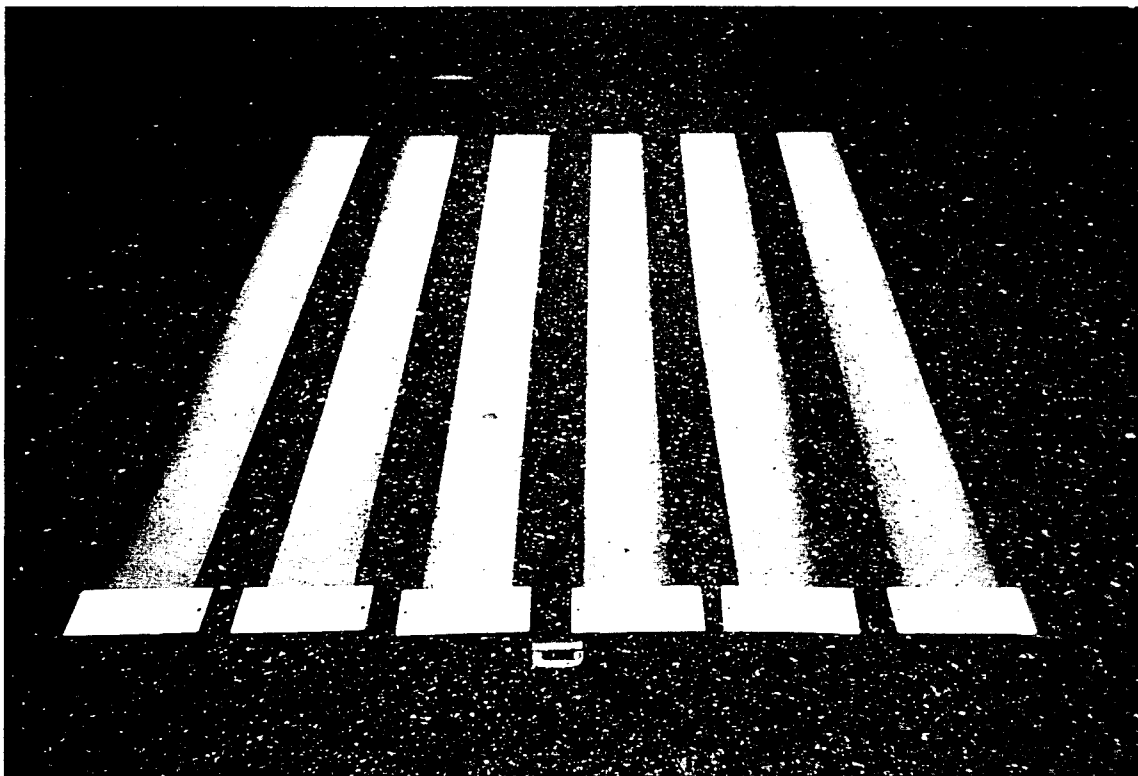
At Atlantic City airport the water-borne material no. 2 was found to have developed a rust-colored cast on the runway threshold stripes and on the asphalt taxiway stripes. Since this occurred only on the asphalt pavement surfaces, it was believed that a component in the asphalt mix was interacting with the materials. Use of drawdowns and comparative photographs illustrated the color transformations that occurred. Refer to the appendix for individual comparisons. Overall, the test materials displayed a constancy in color characteristics with the exceptions already noted.

FIGURE A-24. WATER-BORNE DISCOLORATION - ASPHALT SURFACE

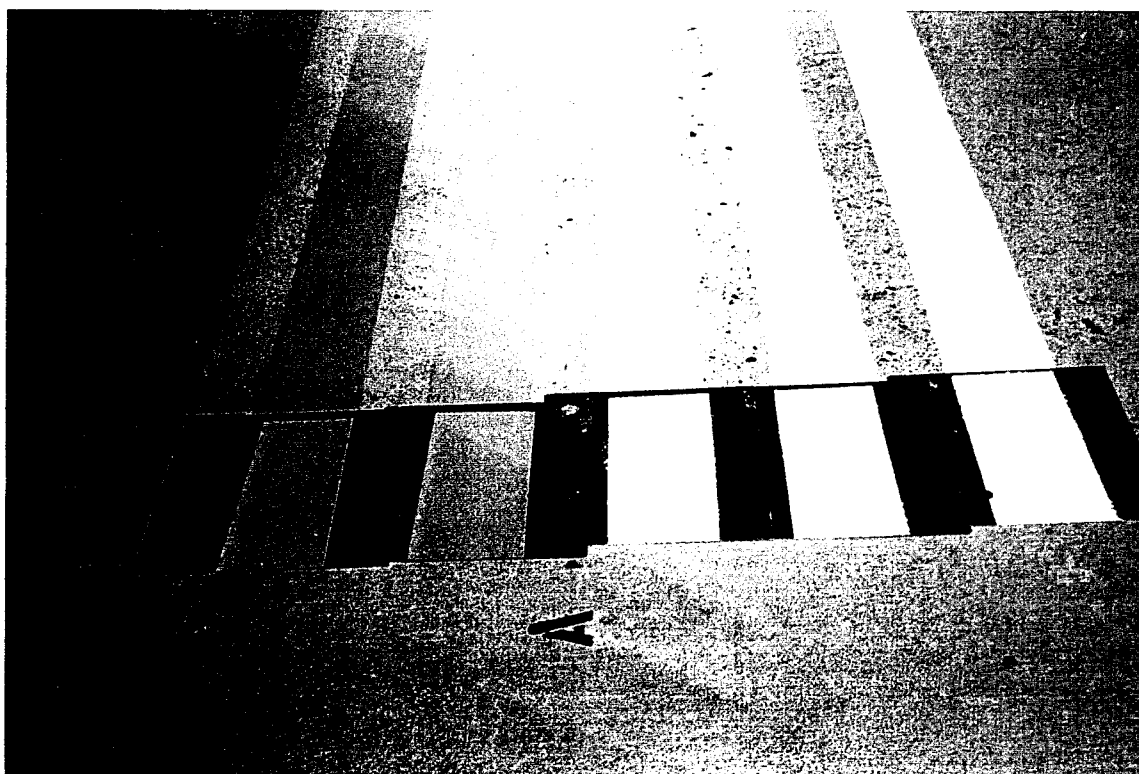
FIGURE A-25. EPOXY NO. 1 DISCOLORATION - CONCRETE SURFACE

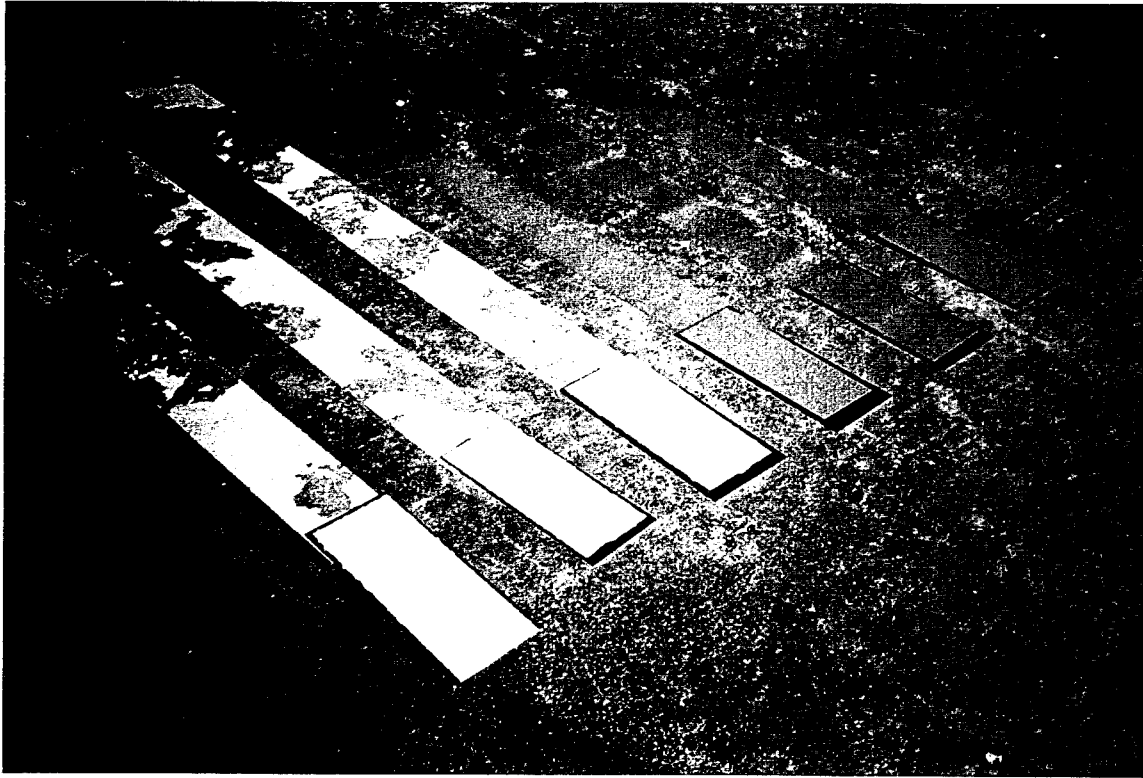
FIGURE A-28. EPOXY NO. 1 TAXIWAY TEST STRIPE AFTER 1 YEAR - PITTSBURGH

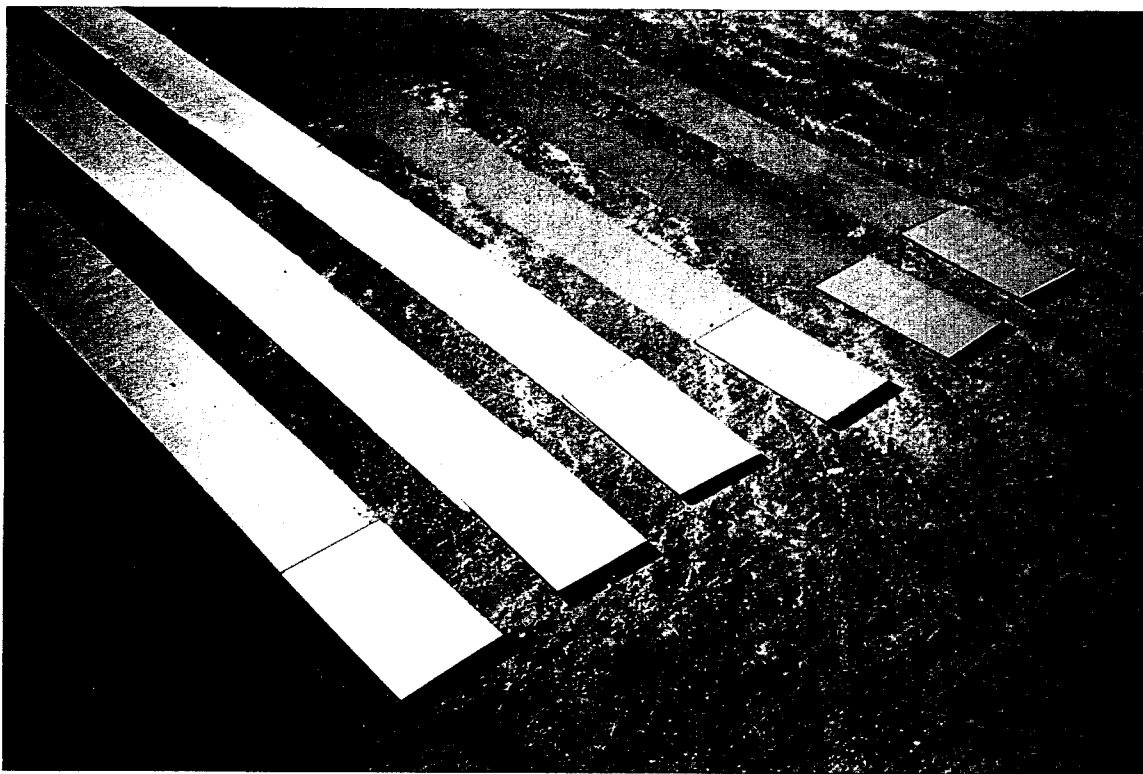
FIGURE A-29. EPOXY NO. 2 TAXIWAY TEST STRIPE AFTER 1 YEAR - PITTSBURGH

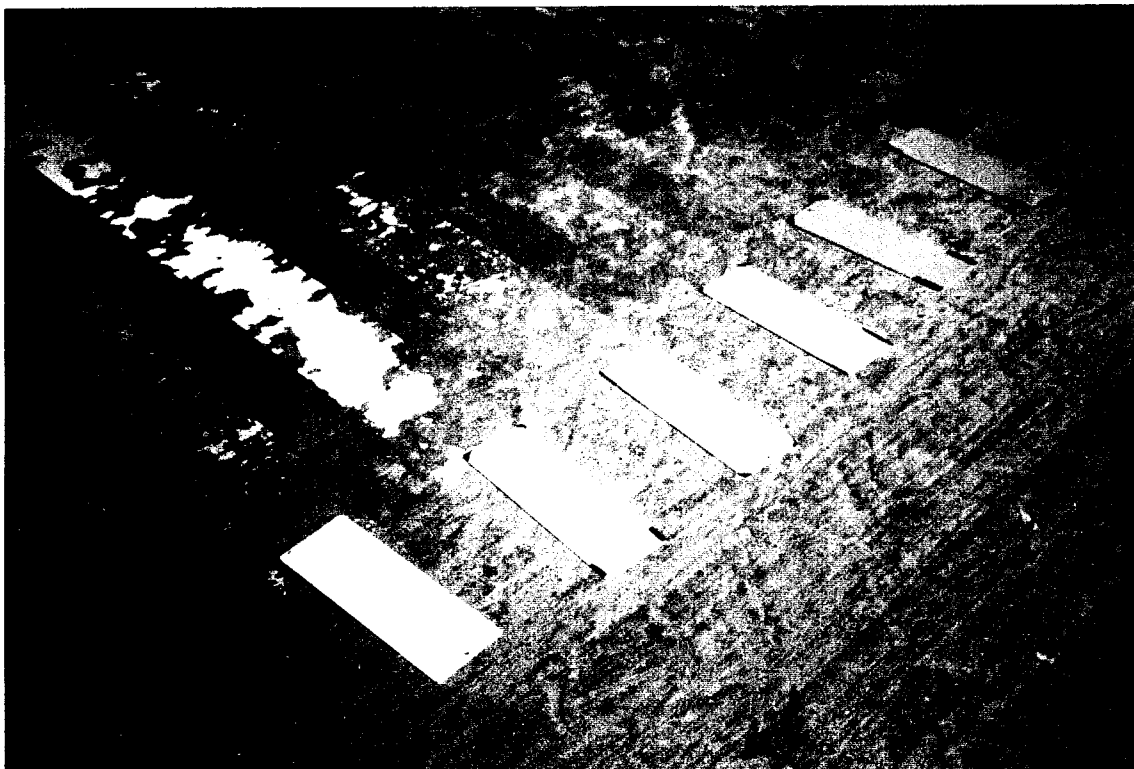
FIGURE A-30. WATER-BORNE NO. 1 TAXIWAY TEST STRIPE AFTER 1 YEAR - PITTSBURGH

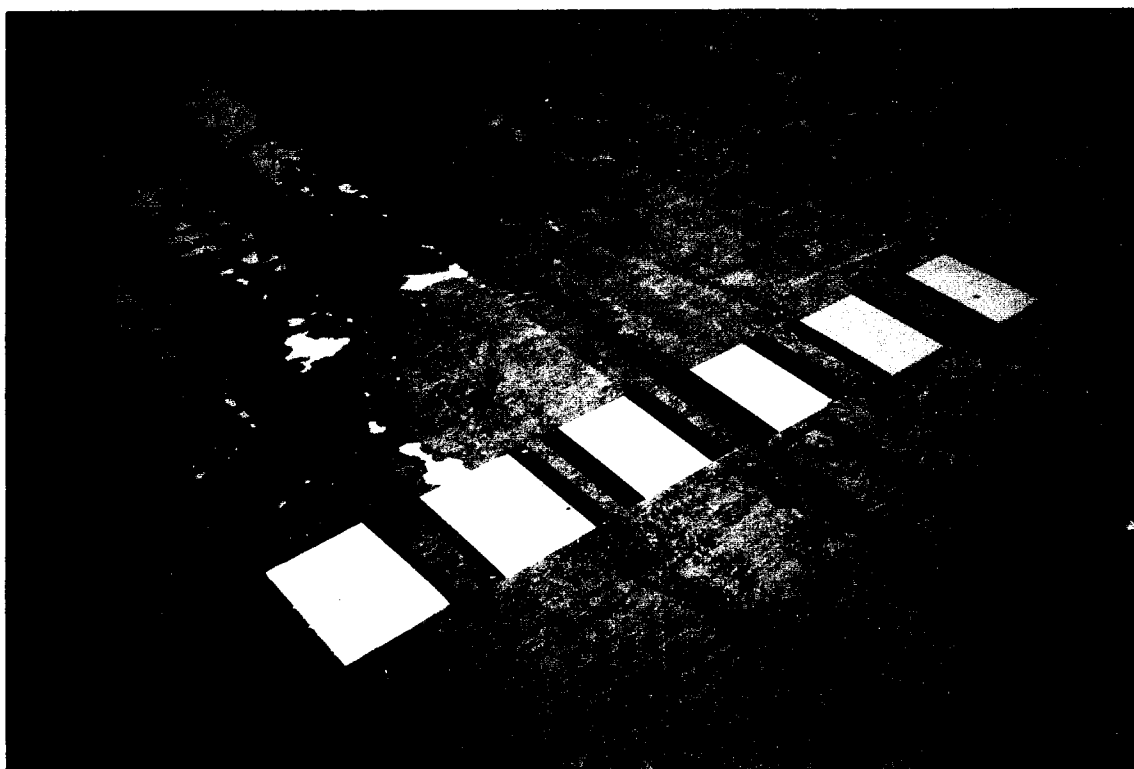
FIGURE A-31. WATER-BORNE NO. 2 TAXIWAY TEST STRIPE AFTER 1 YEAR - PITTSBURGH

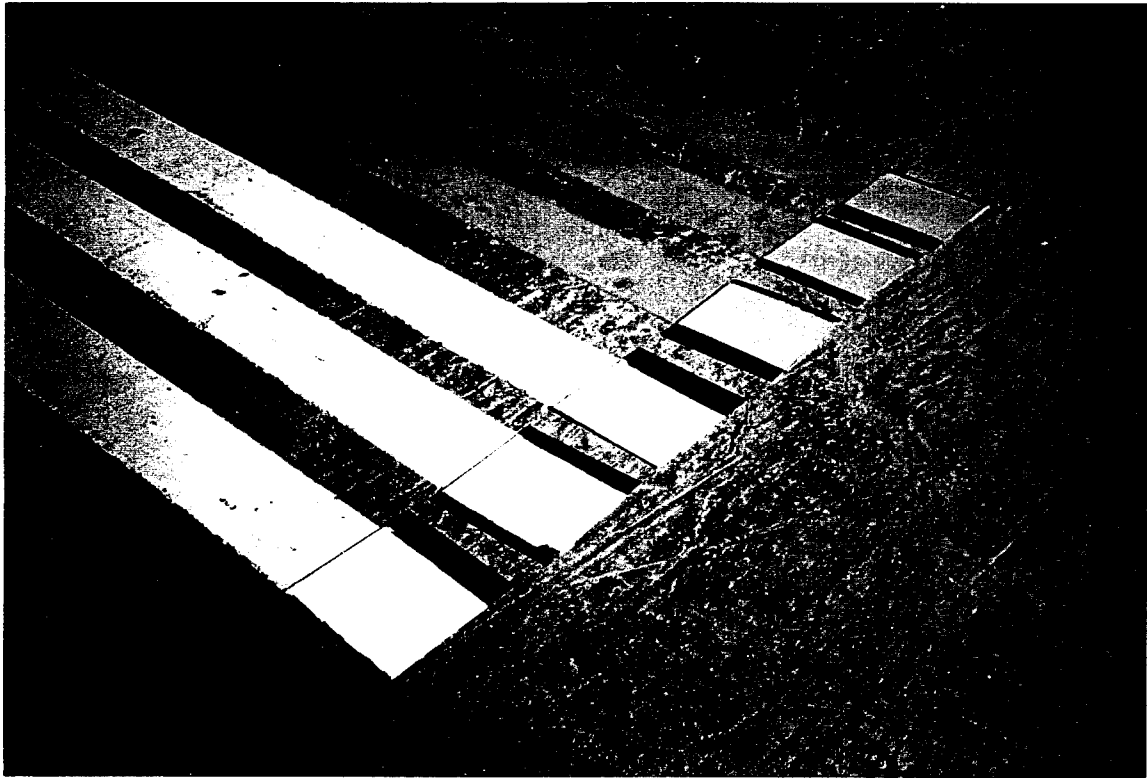
FIGURE A-32. METHACRYLIC RESIN TAXIWAY TEST STRIPE AFTER 1 YEAR - PITTSBURGH
